SAFETY IN BADARPUR: CAN WE MAKE IT A REALITY

A SAFETY AUDIT REPORT BY JAGORI AND SAFETIPIN

2015

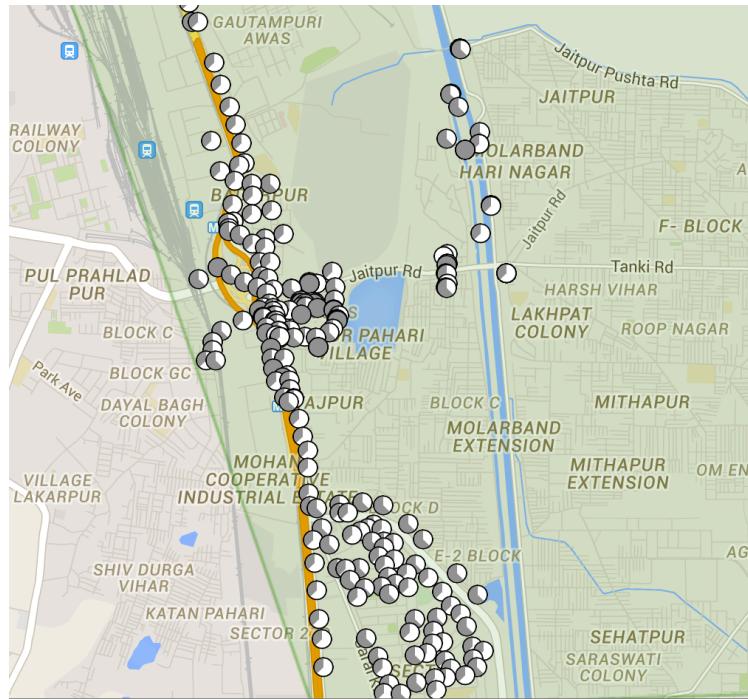
Map 3 below show the levels of light in the routes selected for safety audits. In the map, fully grey spots are areas where there are no streetlights and other sources of lighting, such as lights from inside the houses or shops. Partially grey spots are areas that are partially lit and fully white spots are areas that have bright lighting. From the map it is visible that there are quite a few spots with poor or no lighting.

Repair and maintain lighting. Lighting is a critical issue within Badarpur, and this has significant implications upon the safety of women and girls. As described, streetlights are non-functional or broken throughout the community, and lighting the area surrounding the local metro station is insufficient. Local authorities must repair existing dysfunctional lighting throughout Badarpur, illuminate the area surrounding the metro station, and ensure in the future, that all neighborhood lighting is maintained.

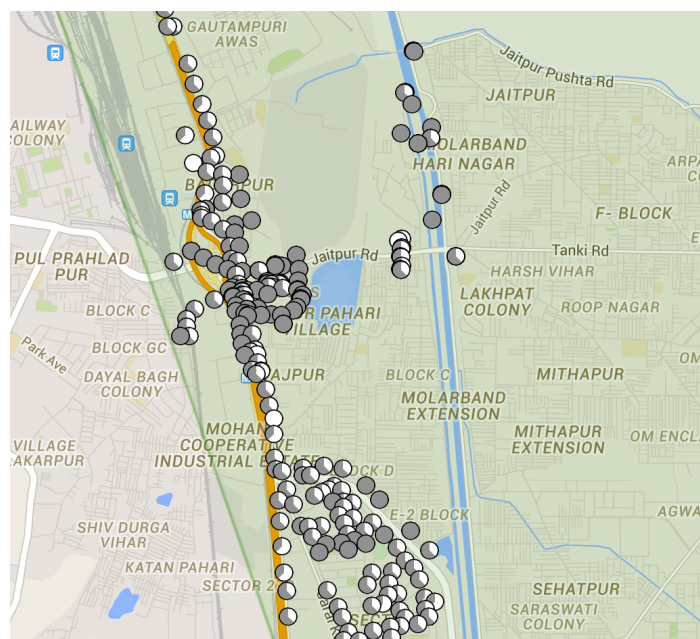
Map 4

Similarly, for the security, map 4 below indicates the level of visible public and/or private security on the selected routes in and around Badarpur. The map shows that large areas have poor security, while some areas have minimal security..

Designate police officers for regular patrolling of Badarpur. The safety audits revealed that there was virtually no presence of public or private security officials inside the colonies themselves, and that on the main road leading up to the metro station, there was an irregular, and certainly minimal security presence. It is important that the Delhi Police maintains a clear public presence in the community, in order to improve perceptions of safety, as well as to increase the accessibility of the police to Badarpur residents. Designated officers should regularly patrol not only the main roads, but also the colonies themselves, and should try “community-oriented policing”- engaging with and building relationships with local residents so that they can work together to prevent and address problems.
