UNDERSTANDING WOMEN'S SAFETY IN MALVIYA NAGAR

Safety Audit Report
Jagori

Malviya Nagar: A Women's Safety Audit Report

2015-2016

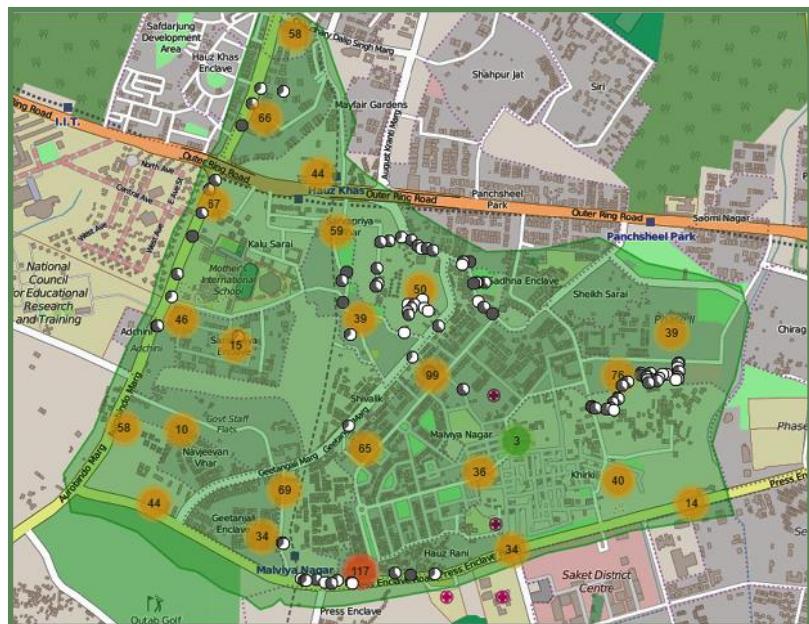
Map (2) - Glimpse of visibility data across Malviya Nagar

Streetlights were stated as one of the fundamental determining factors of safety. The map (2) shows the status of streetlights on the routes selected for safety audits. The map clearly shows that there are quite a few spots with poor or no lighting.

Grey spots - No streetlights and other sources of lighting, such as lights from inside the houses or shops.

Partially grey spots are areas that are partially lit

Fully white spots are areas that have bright lighting

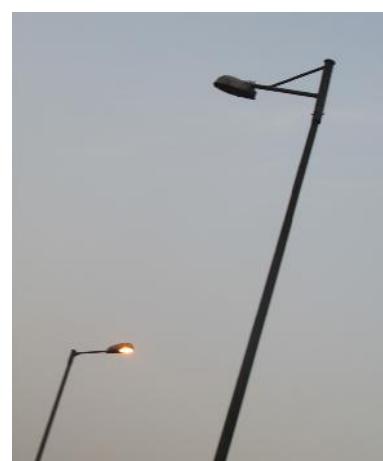
Malviya Nagar Metro Station is often a crowded public space. Even though street light poles were installed along the route, some of the street lights were not functional and few were also broken. Similar observation were also recorded from Sri Aurbindo College to Navjeevan Sarvodaya School near MMTC Gate. Women seldom use the area near Begumpur fort, Kalusarai because it has no provision for street lights. In an audit conducted with a group of women from Jagori survivor's support group on route (3), it was shared that-

Street light at Malviya Nagar Metro Station

Repair and maintain lighting. Lighting has significant implications upon the safety of women and girls. As described, streetlights are non-functional or covered with trees in many parts of Malviya Nagar. Local authorities must repair existing dysfunctional lighting throughout Malviya Nagar, illuminate the area, and ensure in the future that all neighborhood lighting is maintained. Additional lighting should be added to make walking at night safer for women. Local authorities/horticulture dept should ensure regular pruning of tree branches. The street light case should be timely cleaned because the insects gather in there and reduce the effect of lights.

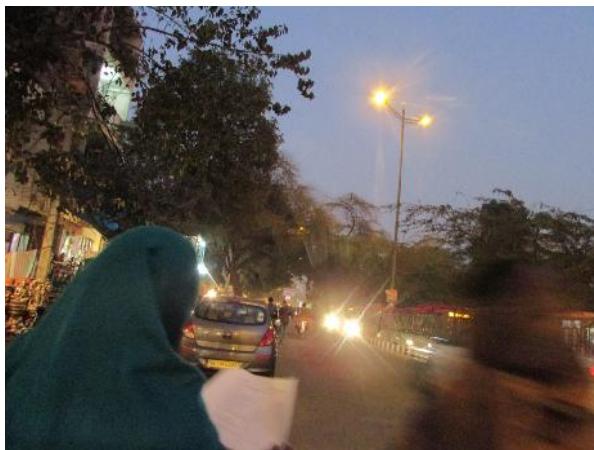
Women auditor

Streetlights poles are installed in the road from Aurbindo College to Sarvodaya School but some of the bulbs are broken and most are covered with trees. Often the lights do not fall on the road leaving it dark for the users of space”

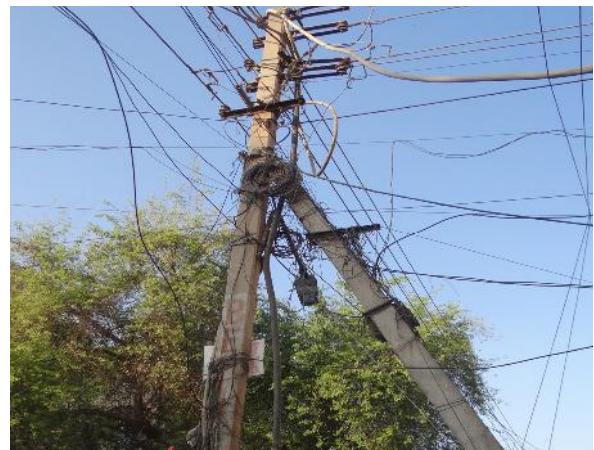
Wired poles and Street lights

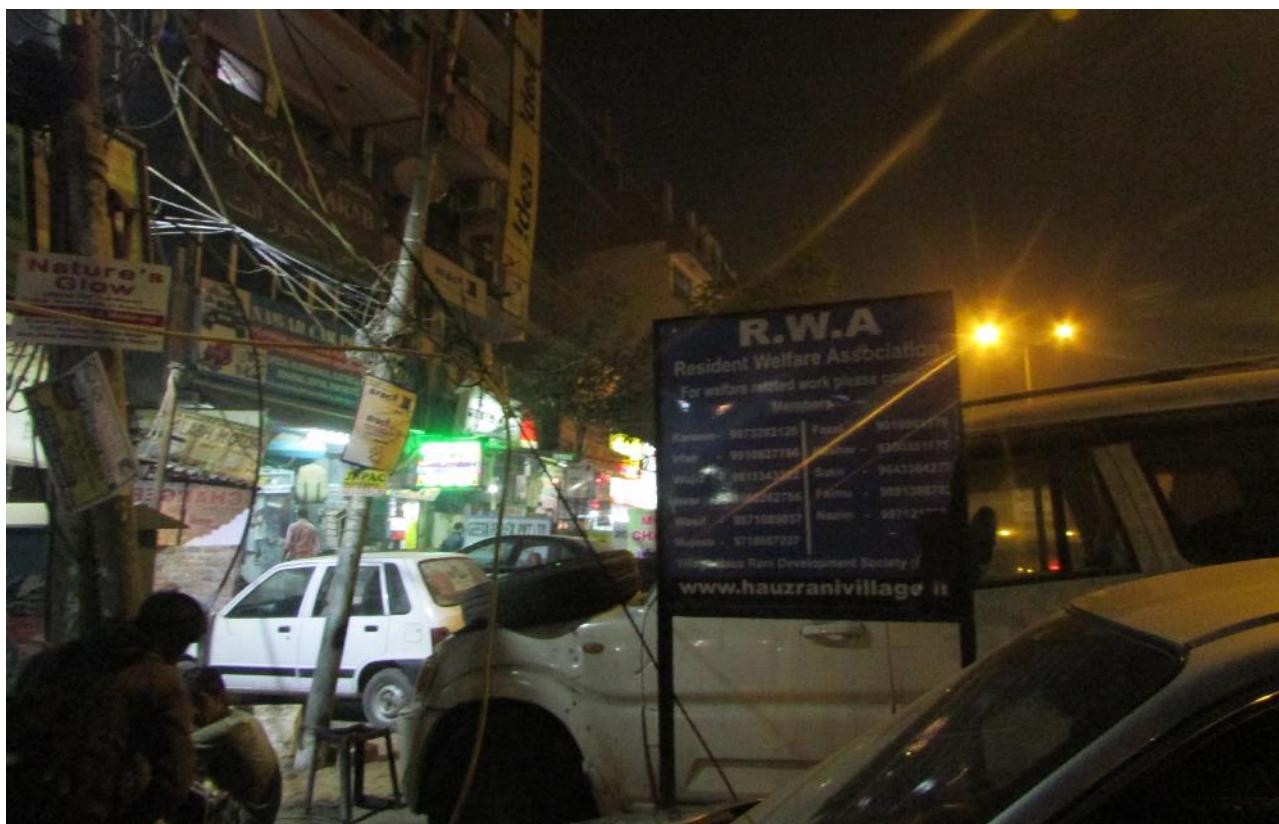
Street lights

There are no lights in the Abbas park. It becomes pitch dark especially in winters and no women are seen in this premise.

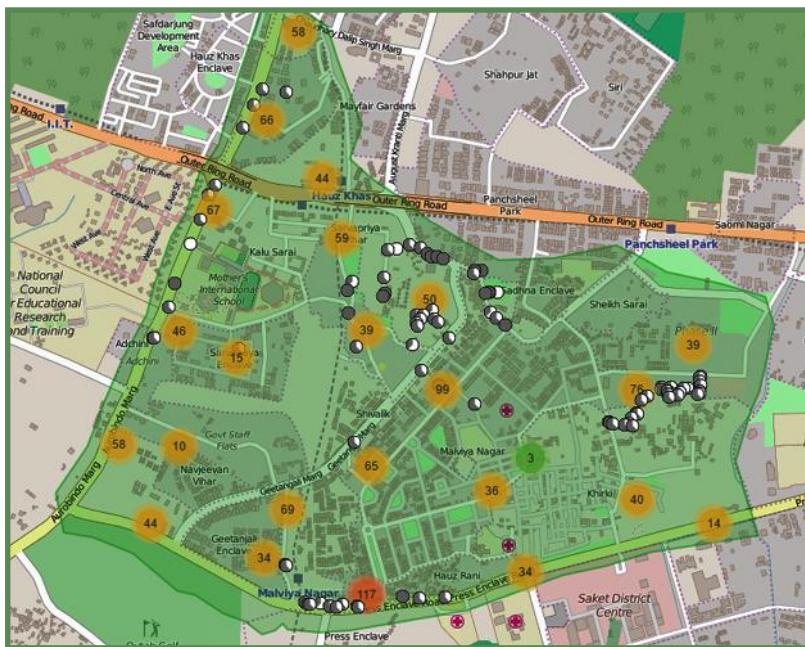
Map (3) - Glimpse of walk paths and pavements data across Malviya Nagar

Map (3) shows the walk-paths in Malviya and its neighborhood. Most of the routes had narrow, high and uneven or broken walk paths.

Grey spots - No or broken walk paths.

Partially grey spots are partially broken walkpaths.

Fully white spots are walkpaths in a even and walkable state.

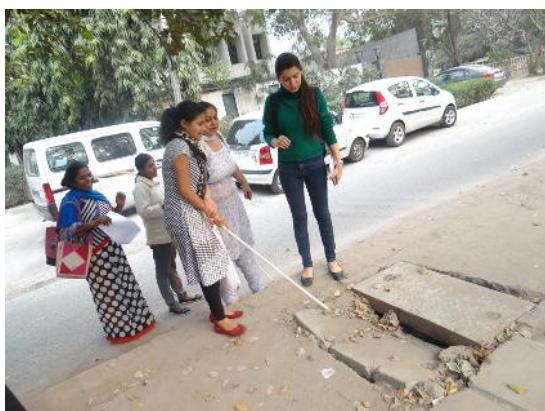
Pedestrians constitute one of the most vulnerable groups on roads. The footpath along the road from Sarvapriya Vihar to Hauz Khas Metro Station was very fragmented with several open manholes. This particular audit was conducted with students from National Association for Blind who found the pathways inaccessible. Street crossing with fast moving and heavy traffic was another concern shared by the group.

Pavements for visually impaired users

Ensure that streets are open and walkable. Sidewalks must be widened. The ramps on the bus stops and pavements must be fixed so that people with strollers, those who are visually impaired and individuals using a walker or a wheelchair can use it effectively.

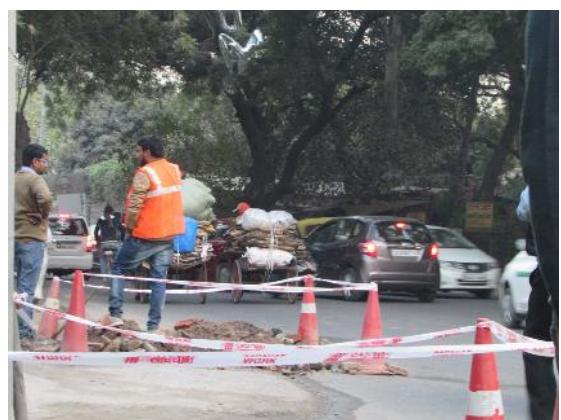
Ongoing sewer work-dug pavements

Domestic workers from Begumpur are regular commuters on IIT flyover to Adchini road. The footpath on this road was dug up for ongoing sewer work leaving no space for pedestrians. Cars were parked along most of the roads further blocking the pedestrian space. Road from Sarvapriya Vihar to Malviya Nagar was also observed to be highly accident-prone.

Residential areas in places like Begumpur have many narrow streets. Hence, authorities must ensure that these narrow streets remain clear of vehicles, rubbish or any other debris, and that sewage drains and gutters are safely covered. Designated parking zones for auto rickshaws should be established. Hawker Zones should be created such that the pedestrian movement is not hindered.

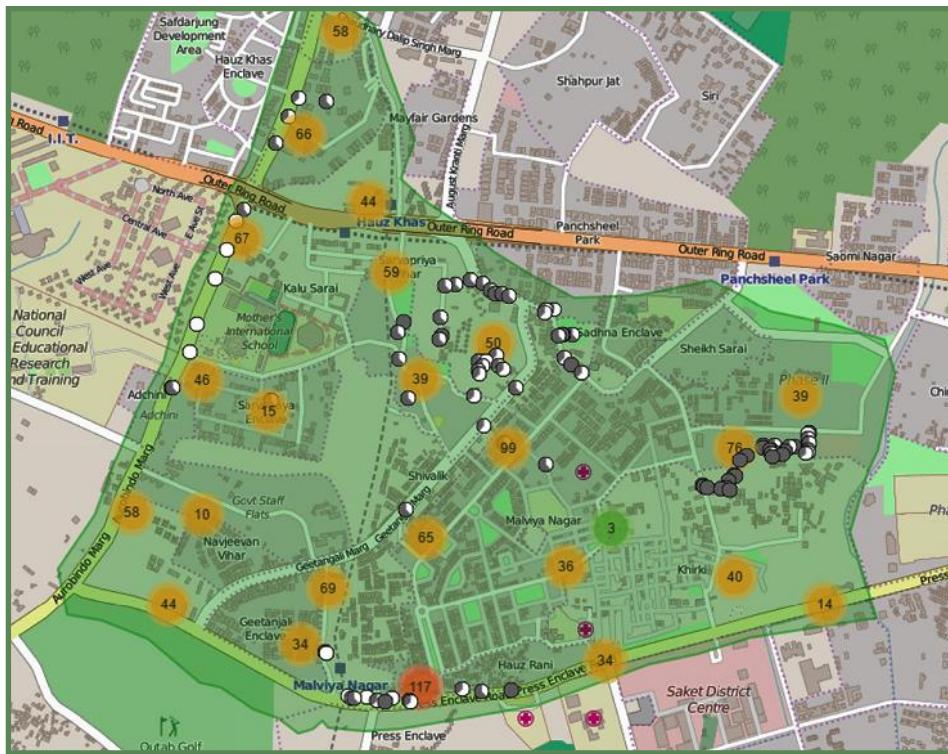
Map (4) - Glimpse of transport service data across Malviya Nagar

Map (4) shows the public transportation system in Malviya Nagar and its neighborhood. The main roads are connected by Delhi metro and Bus services. The auto rickshaws are also available on the main roads. People staying in the interior residential areas raised their concern about last mile connectivity.

DTC Bus stops in Malviya Nagar were newly designed with route numbers displayed on most them, however some gaps were clearly pointed out regarding their maintenance and frequency of buses. Some bus stops had inaccessible ramps and broken seats. Unauthorized parked cars and two wheelers also blocked the waiting area in a few places.

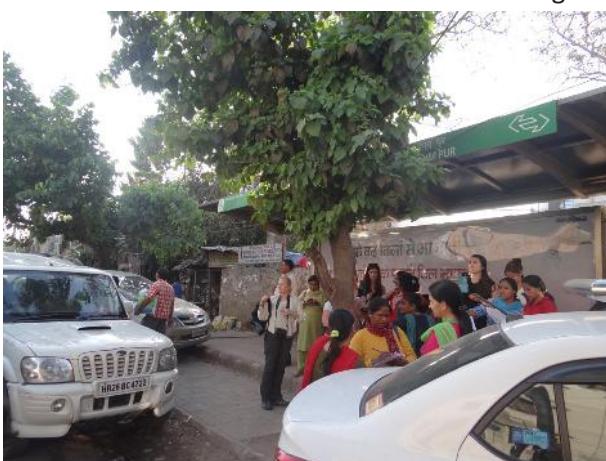
Cars obstructing Begumpur Bus Stand

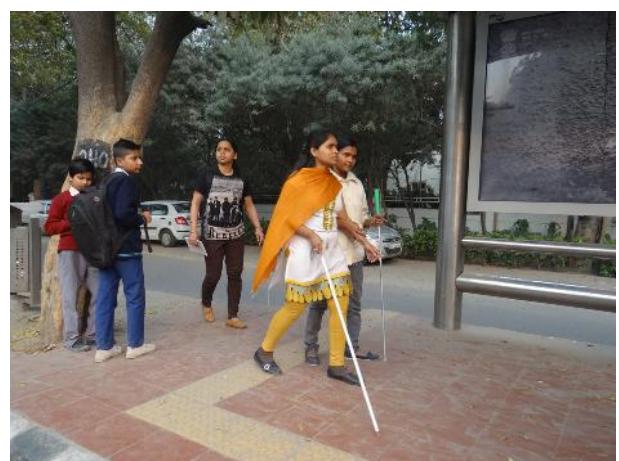
The tactile paving which is supposed to indicate a change in the direction for the visually impaired, is often incorrect and inconsistent therefore misleading.

Tactile paving in Sarvapriya Vihar Bus Stand

Tactile pavings should be at every footpath and bus stop. If a tree grows in the middle of the footpath, the tactile paving breaks off abruptly. It should therefore go around the tree to direct the users properly.

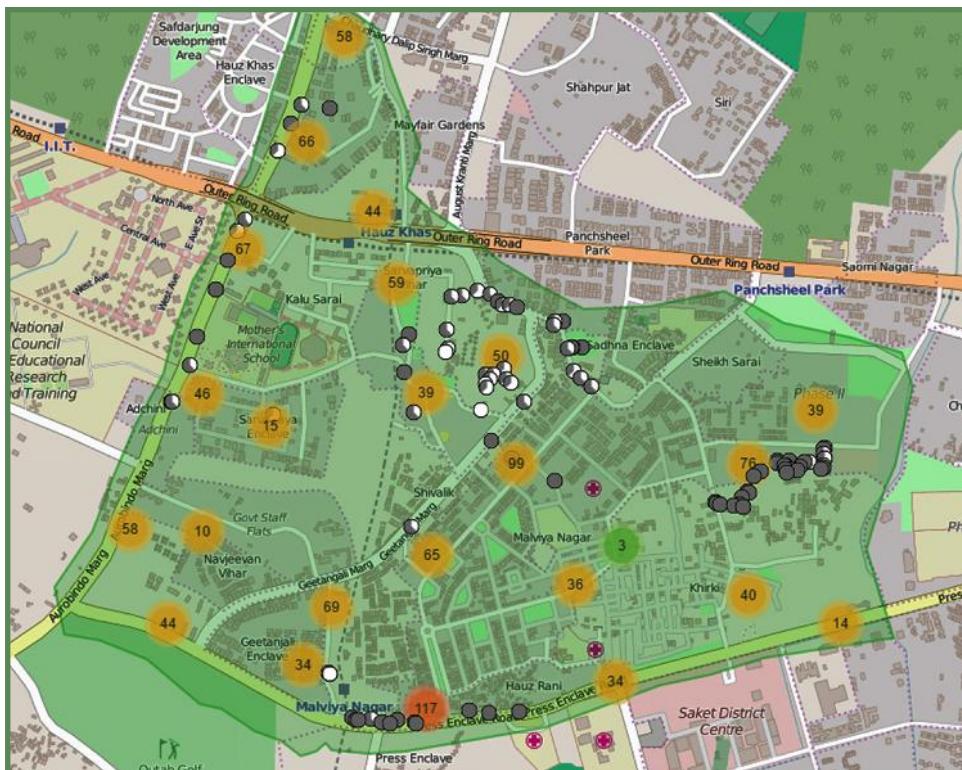
Map (5) - Glimpse of security data across Malviya Nagar

Map (5) indicates the level of visible public and/or private security on the selected routes in and around Malviya Nagar. The map shows that the level of security varies across different routes. Some routes had no security provisions. Most women were of opinion that visible policing positively affects the feeling of security.

Grey spots - Lack of patrolling and visible security

Partially grey spots show moderate security either private or police

white spots show visible policing like checkpost, PCR vans, working CCTV cameras etc

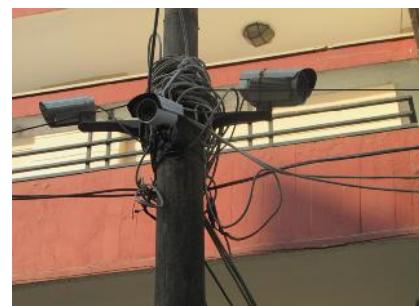
The CCTV cameras were installed at the metro station. Shopkeepers in the main market have also installed cameras with the intention of preventing theft. There is a police station near Malviya Nagar Metro Station but the lack of patrolling was evident on other routes. One of the concerns shared by the team was:

"The angles of the CCTV camera may not capture the incidence but it focuses on the traffic rule breakers only"

Working CCTV Camera

Designate police officers for regular patrolling. There was virtually no presence of public or private security officials inside the colonies. Police Booths at strategic locations in the neighbourhoods should be made. Designated officers should regularly patrol not only the main roads but also inside the colonies.

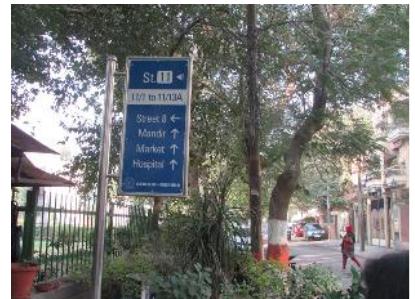
As far as signage is concerned, Malviya Nagar recorded fairly good signage in public spaces. It is placed after frequent intervals in Hindi and English.

Signage in Malviya Nagar

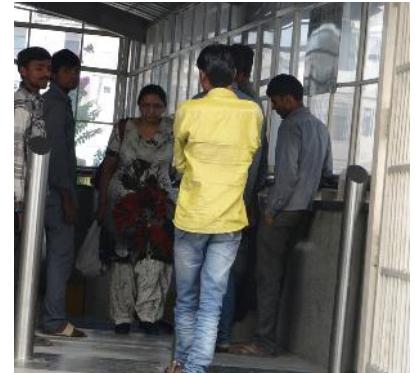
Another concern was the attitude of auto drivers who stand in groups outside the escalators of Malviya Nagar metro station. They obstruct the exit passage that particularly make women passengers feel uncomfortable.

Auto drivers outside Malviya Nagar Metro Station
