SAFETY IN BADARPUR: CAN WE MAKE IT A REALITY

A SAFETY AUDIT REPORT BY JAGORI AND SAFETIPIN

2015

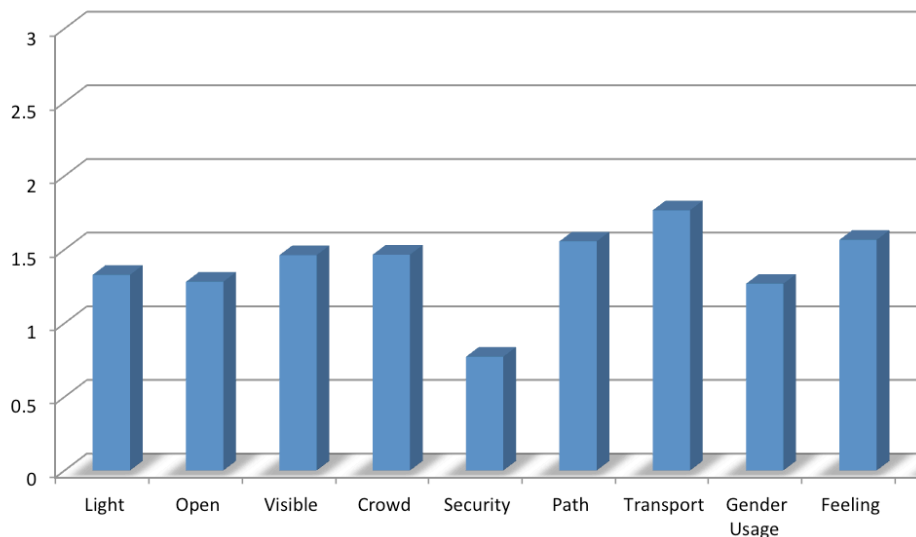
Graph 1

The area surrounding Badarpur falls under South Delhi district, one of the affluent belts in the city. However, with poor lighting, lack of public and private security, lack of openness and low gender diversity in the area, the areas is perceived as unsafe, especially by women. The graph below (Graph 1) indicates the average score of each safety audit parameter:

Findings from the safety audits show that all the audit parameters except for public transport are below average, with 4 parameters being particularly low—openness of the area, street lights, presence of public and/or private security and gender diversity in the area. All the other parameters such visibility, presence of people, walk path, availability of public transport and feeling of safety score higher in relation to others. However, they all score below average.

Area	Av Rating	Description
Lighting	1.3 – Below Average	It was seen that streets lights in many parts of Badarpur do not work/ are broken. Area near the metro station is particularly dark in the evening.
Openness	1.3 – Below Average	The houses are divided by narrow streets, main streets are occupied by auto rickshaw parking and street hawkers.
Visibility	1.5 – Average	The inner areas of Badarpur have relatively better visibility due to shops and houses. After dark, visibility on main roads is minimal.
Crowd	1.5 – Average	There is enough crowd throughout the day.
Security	0.8 –	There is no visible public and private security

Poor	inside the colonies. On the main road towards the metro station there is irregular and minimal security.
Walk Path	1.6 – Average	Partially constructed walk paths, mostly encroached upon by street hawkers and bike parking. Residents complain of littered streets that makes it difficult to walk.
Gender Usage	1.3 – Below Average	Gender diversity post dark is poor. Women step out in the evening in times only if necessary .
Transport	1.8 – Above Average	Public transport like auto rickshaws are available in the inskirts of Badarpur colonies and metro line runs closeby the market area.

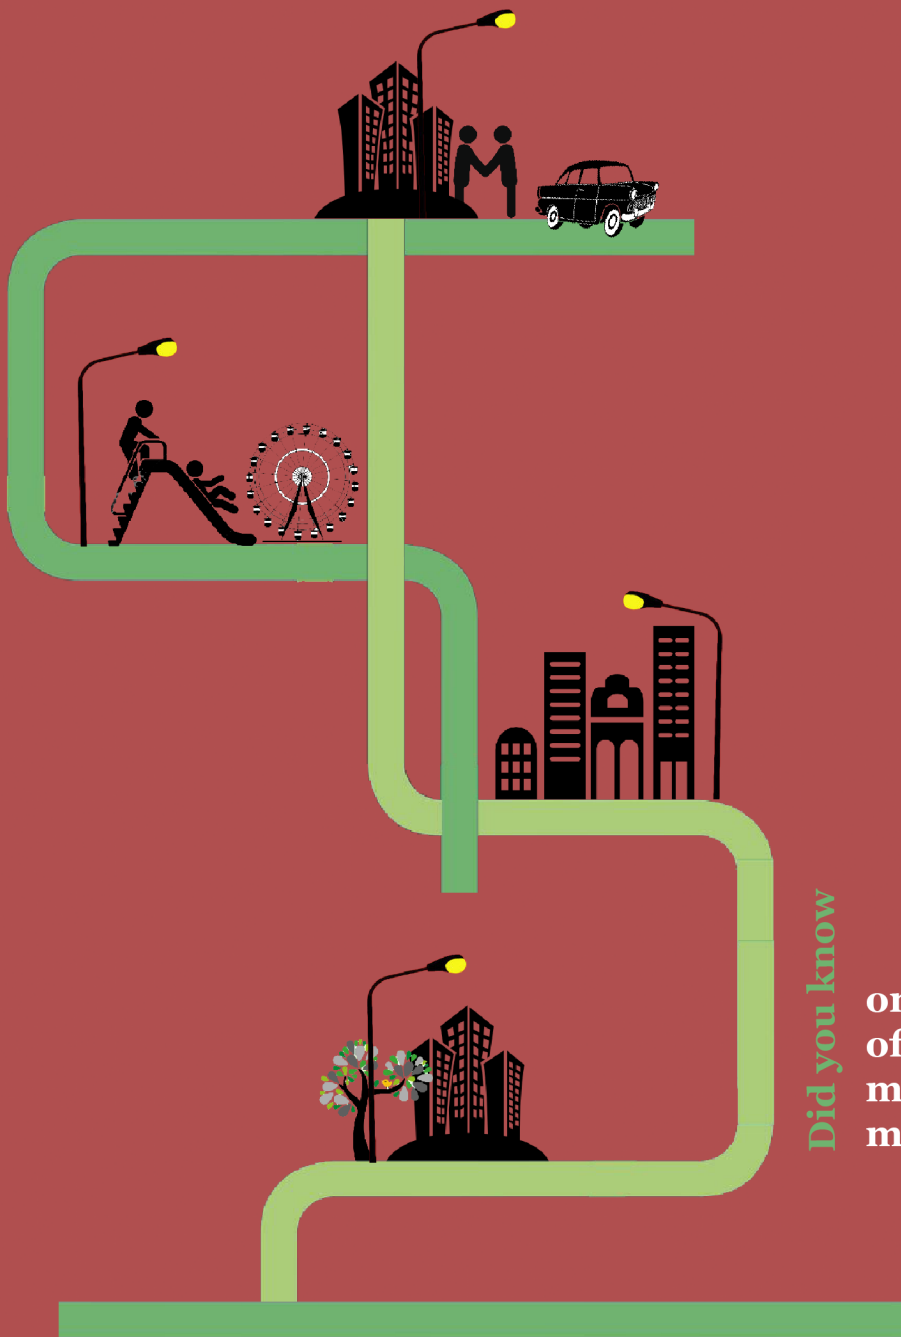
Most streets and public places are not well lit. Poor maintenance of streets lights is seen as a key reason for no light in most spaces.

only 43%
of Badarpur is lit;
mostly near the
main road.

Repair and maintain lighting. Lighting is a critical issue within Badarpur, and this has significant implications upon the safety of women and girls. As described, streetlights are non-functional or broken throughout the community, and lighting the area surrounding the local metro station is insufficient. Local authorities must repair existing dysfunctional lighting throughout Badarpur, illuminate the area surrounding the metro station, and ensure in the future, that all neighborhood lighting is maintained.

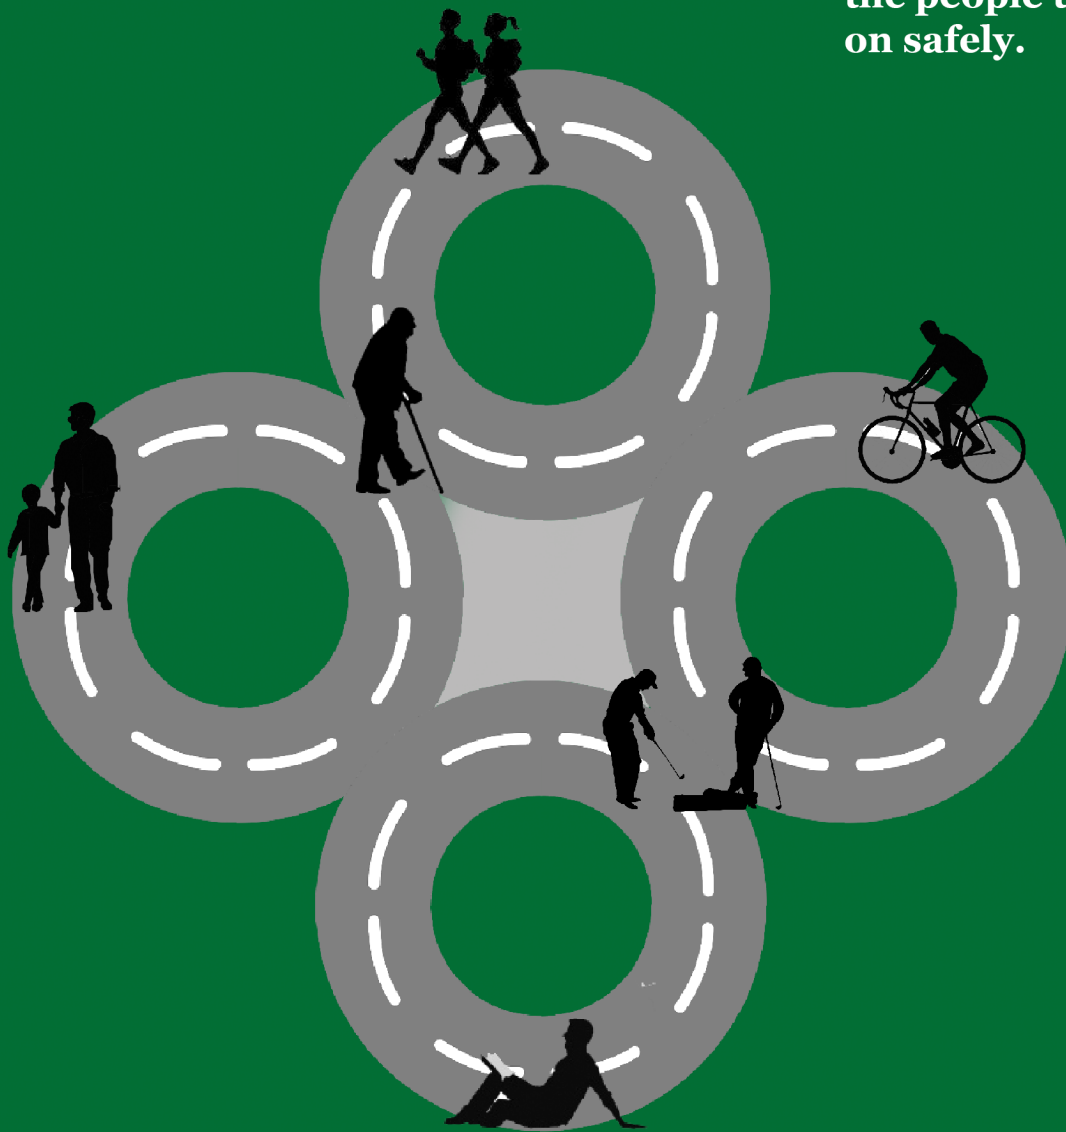
Most streets and public places are not well lit. Poor maintenance of streets lights is seen as a key reason for no light in most spaces.

53% of Badarpur has no walkpath for the people to walk on safely.

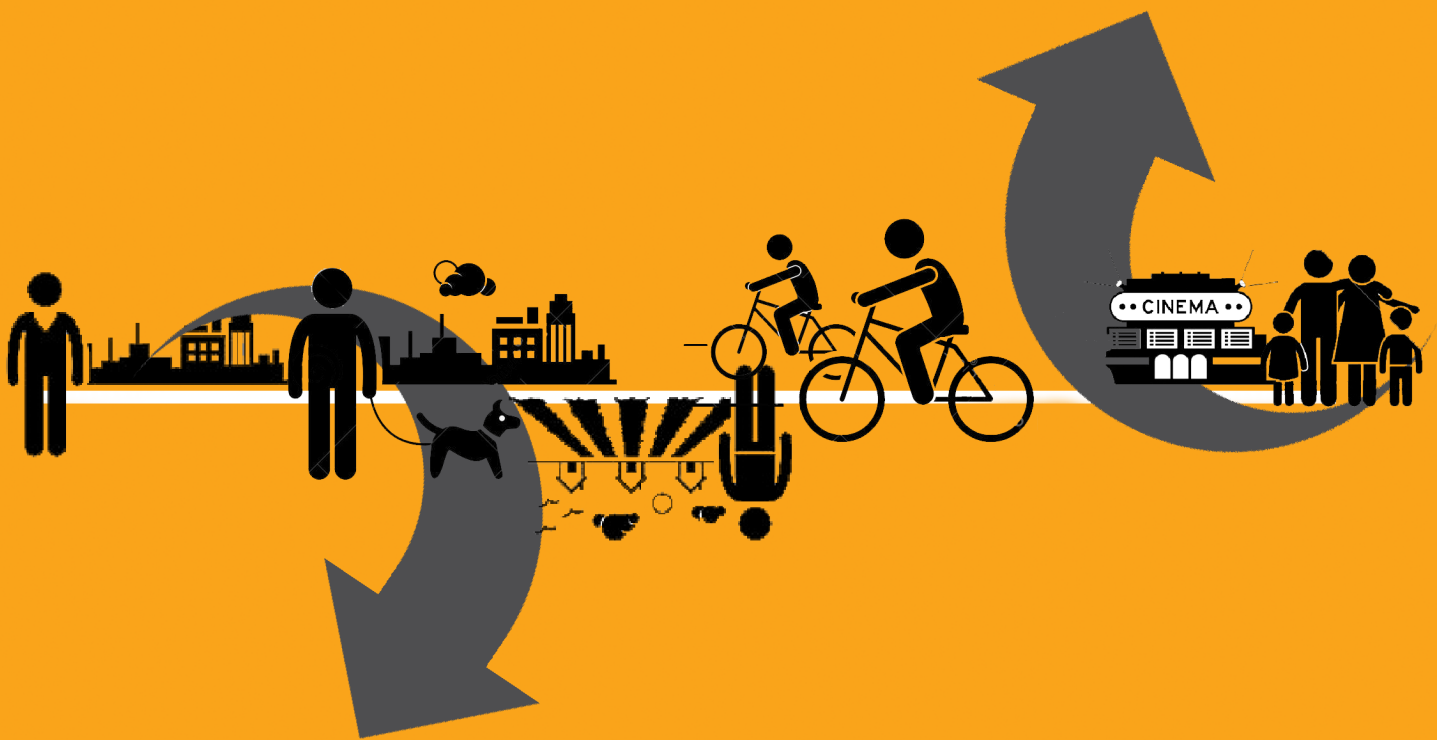
Mobility of women is limited depending on the kind of public place and the hour of the day. Mostly women feel uncomfortable after dark and are seen often accompanied by men.

57% of Badarpur is not gender friendly. Women venture out only when necessary or with male companions.
